RM No. E7J23

CYCLIC ENGINE TEST OF CAST VITALLIUM TURBINE BUCKETS - I

By J. Elmo Farmer, F. N. Darmara  
and Francis D. Poulson

## NATIONAL ADVISORY COMMITTEE FOR AERONAUTICS

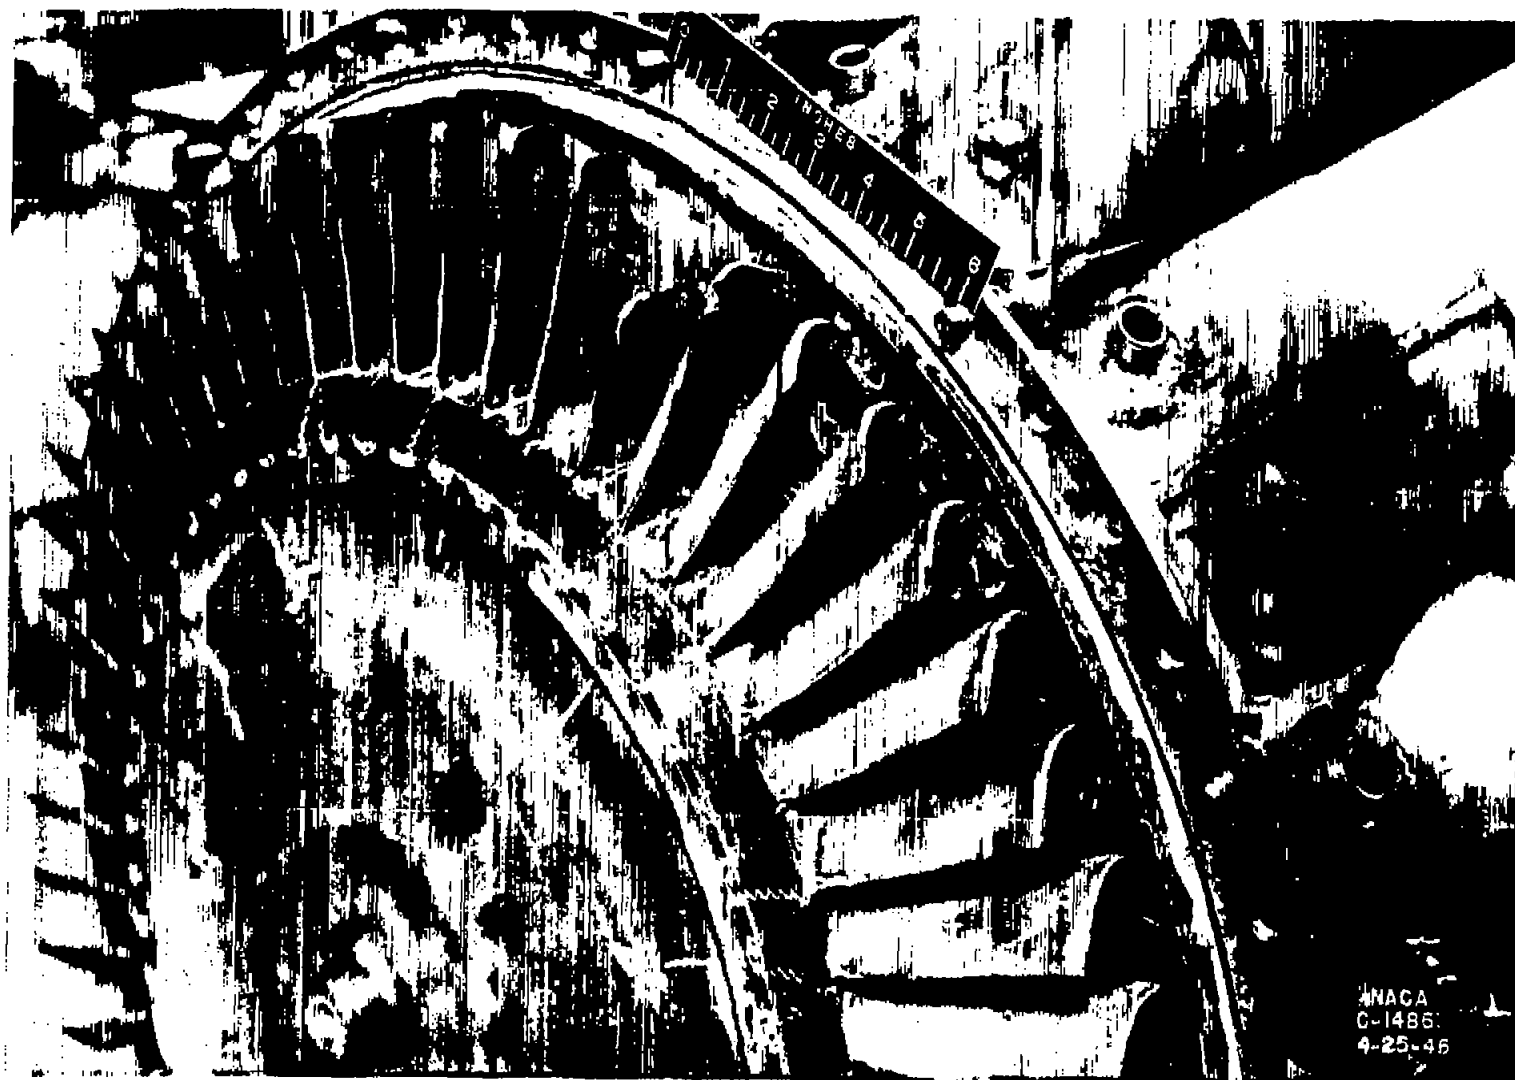
Wheel 1. - Wheel 1 was installed in an engine and was run-in by the engine manufacturer prior to the tests at the Cleveland laboratory. The first failure on wheel 1 occurred during cycle 22 after 7 hours and 20 minutes. The broken bucket (bucket 1-13), shown in figure 6, was replaced, the wheel rebalanced, and the runs

Figure 6. - Wheel 1 after first bucket failure (bucket 1-13), which occurred during cycle 22 (7 hr, 20 min).

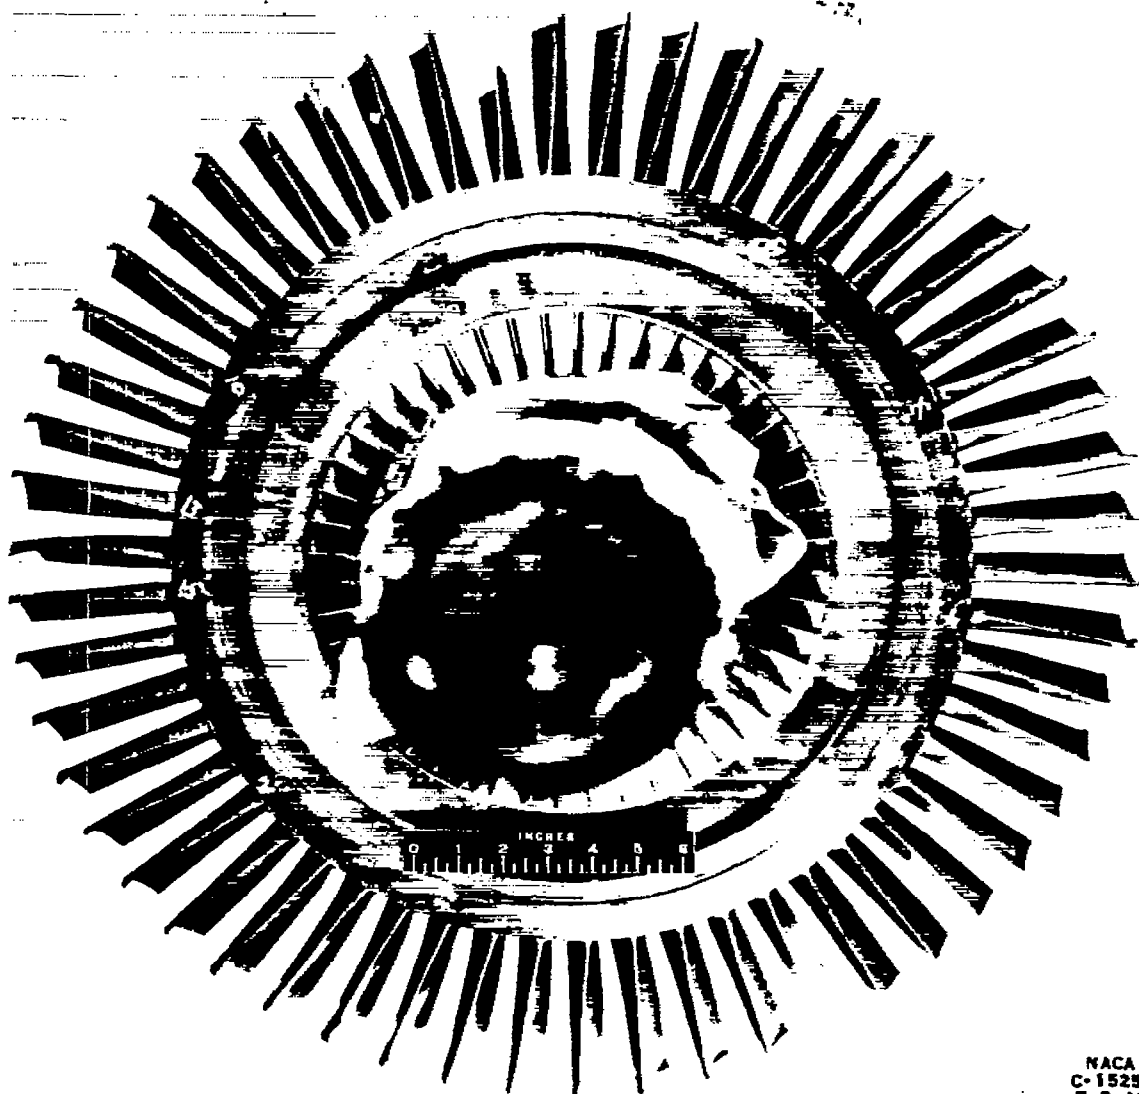
continued. Bucket 1-2 failed three cycles later during cycle 25 after a total running time of 8 hours and 12 minutes (fig. 7). Buckets 1-12 and 1-14 were removed for comparison with the broken buckets.

Figure 7. - Wheel 1 after second bucket failure (bucket 1-2)  
which occurred during cycle 25 (8 hr, 12 min).

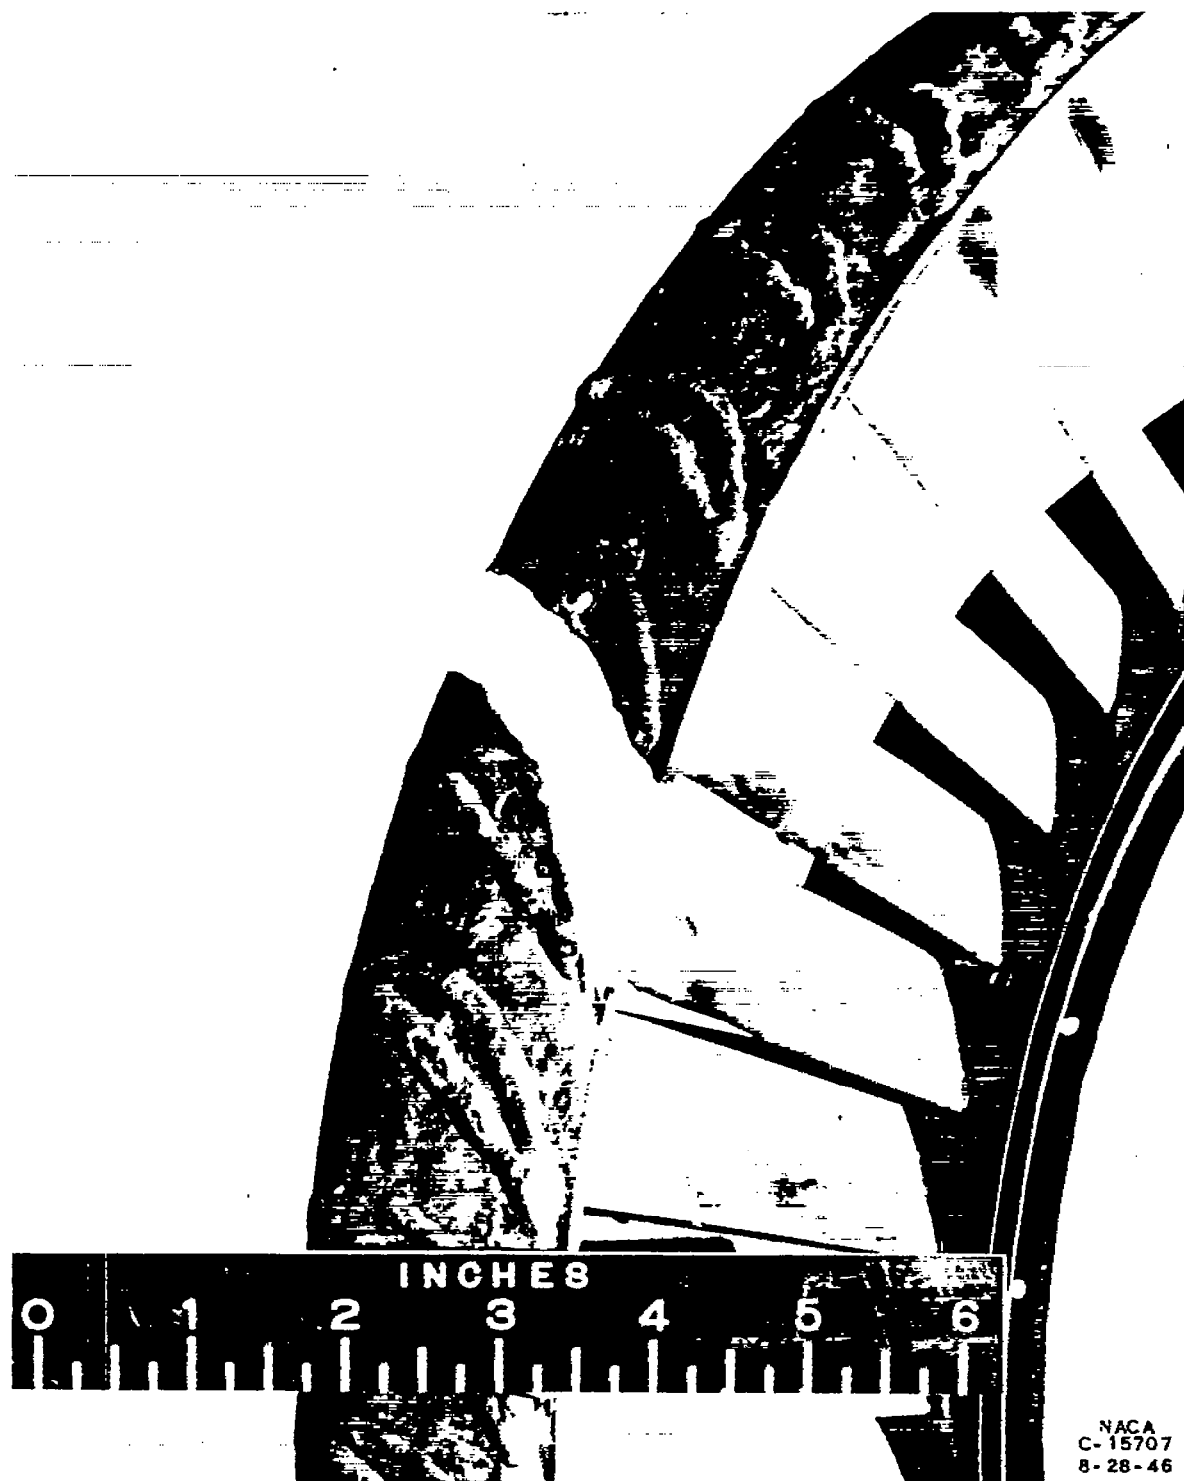
After 11 hours and 8 minutes, the ring-and-tube assembly was found to be so badly damaged that the engine could not be run. The damage sustained by one of the outer flame tubes is shown in figure 9. Operation was resumed after the ring-and-tube assembly had been replaced. An inspection after a total running time of 28 hours and 44 minutes showed that the nozzle diaphragm had been badly eroded (fig. 10) and that the stiffeners on the compressor cover plate were cracked.

Figure 10. - Damaged turbine-nozzle diaphragm from engine after 28 hours and 44 minutes.

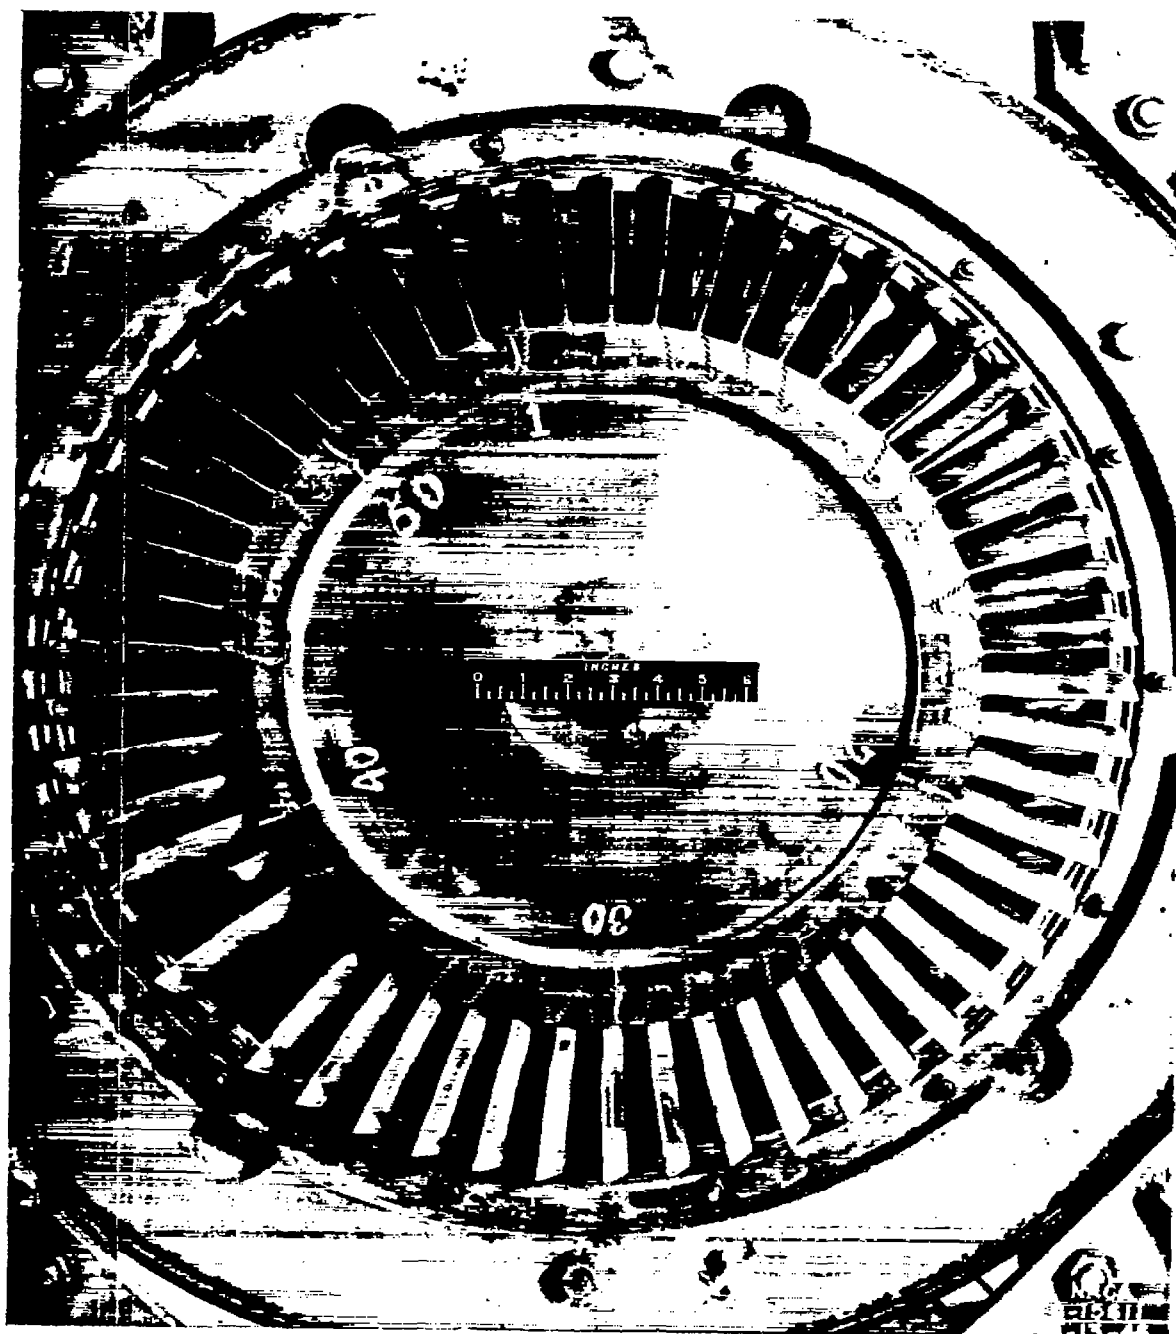
The turbine wheel was therefore removed, installed in another engine, and the running resumed. After cycle 229 (76 hr, 20 min total running time), the nozzle diaphragm was again found to be in bad condition and the engine was removed from the test cell for overhaul. No bucket failure had occurred. Many of the buckets had shifted in the axial direction, six of them sufficiently to rub on the gas baffle in the exhaust cone (fig. 11). Two buckets (buckets 3-16 and 3-43) were removed from wheel 3 for comparison with the broken buckets from the other wheels.

Figure 11. - Wheel 3 after a total running time of 76 hours and 20 minutes showing axial shift of buckets.
